Analysis Of Trees Damaged From Flooding And Ice In Columbus, Nebraska

ANALYSIS OF TREES DAMAGED FROM FLOODING AND ICE IN COLUMBUS, NEBRASKA

AN UNDERGRADUATE THESIS

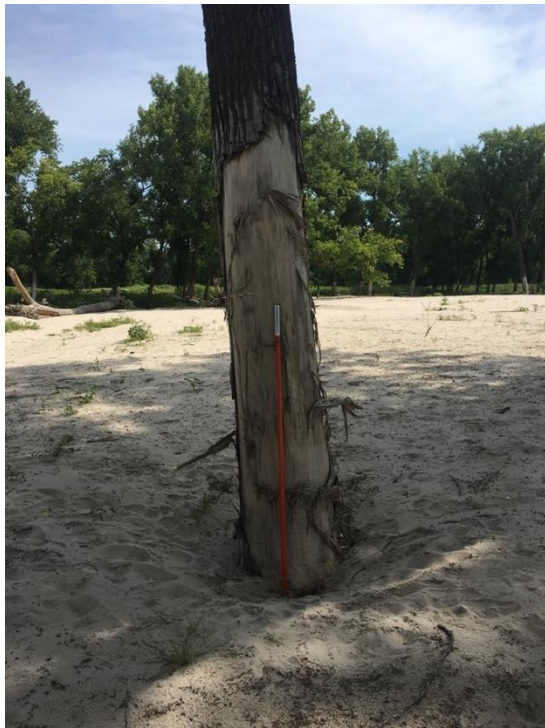
The flow of the water was moving northeast, and therefore the damage on the trees was seen on the south and west sides of the trunks. Figure 1 shows the kind of damage that was created due to ice rubbing against the bark and sand being displaced from the river.

Figure 1. Ice damage on the southwest side of a cottonwood.

deficiency; these trees should be watched in the years to come to determine if treatment is necessary. All of the trees that have scarring from the ice in the flood should be monitored for signs of declining health. This can be determined by examining the new growth on the twigs to see if it has grown less than previous years. Foliage is also a good way to determine the health of a tree. If the leaves are abnormally small or discolored, this could be a symptom of declining health.
